DUNMORE NO. 3 DAM

NDI ID NO. PA-00376

PHASE I INSPECTION REPORT
NATIONAL DAM INSPECTION PROGRAM

FEBRUARY 1979

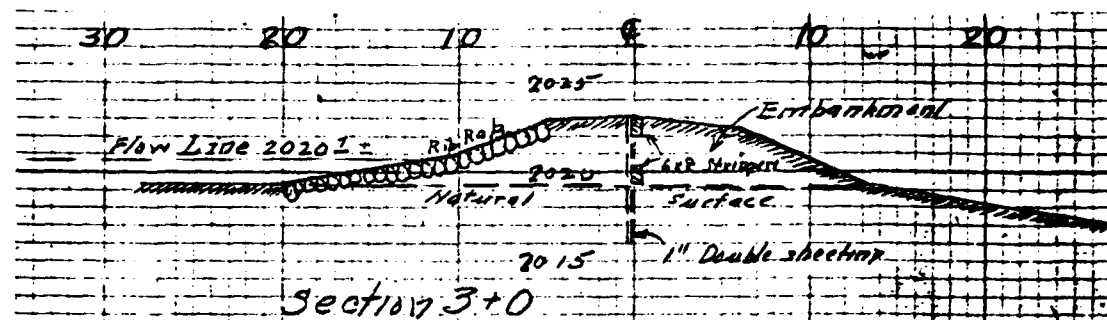
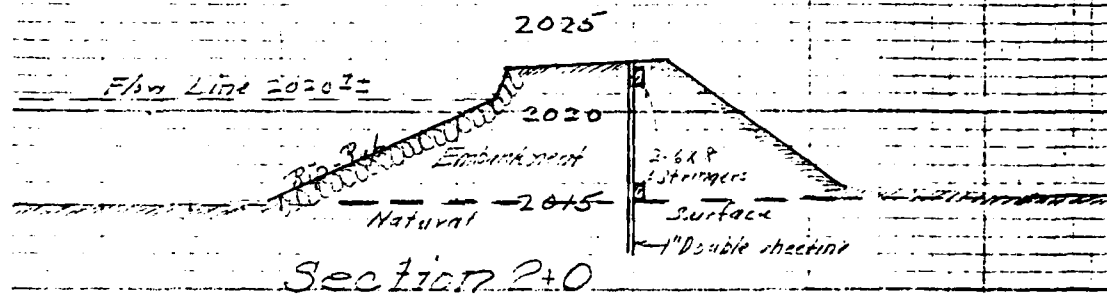
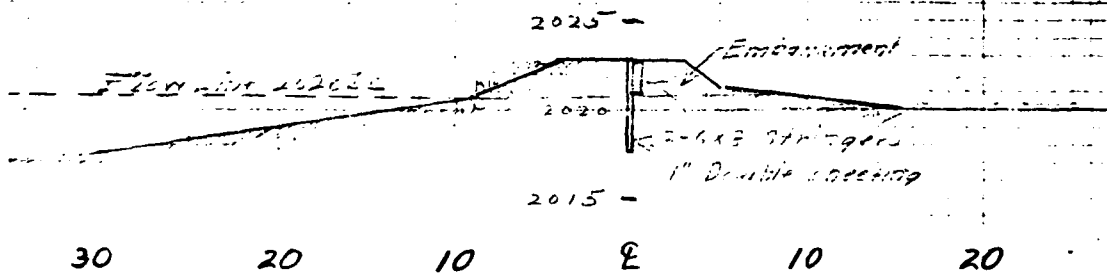
PHASE I INSPECTION REPORT
 NATIONAL DAM INSPECTION PROGRAM
 DUNMORE NO. 3 DAM
 PENNSYLVANIA GAS AND WATER COMPANY
 LEFT EMBANKMENT SECTIONS
 FEBRUARY 1979

Plates 3 and 6 indicate that the slopes of the left embankment vary also. The downstream slope is about 1V on 1.4H at the steepest section. The report prepared in 1914 by the Pennsylvania Water Supply Commission indicates that the right embankment had upstream and downstream slopes of 1V on 1H and 1V on 1.25H, respectively. The left embankment was described as of irregular cross section. This variation between the observed slopes and the slopes described in the report is the basis for believing that the embankment was modified in 1919.

The 1914 Pennsylvania Water Supply Commission Report states that there is no core-wall in the embankment, as far as is known. It is not known where the information on Plates 5 and 6 was derived. These plates are undated. The core-wall is described on these plates as "double 1-inch sheeting" with 6-inch by 8-inch stringers. The value of such a timber core-wall is dubious. Such a thin timber section cannot be considered to add significant shear resistance to the embankment. Its ability to act as a watertight structure is also doubtful. Furthermore, considering its age, its condition in the zone of a fluctuating phreatic surface must be questionable. It is not considered that the core-wall can be relied on to act as an effective cutoff.

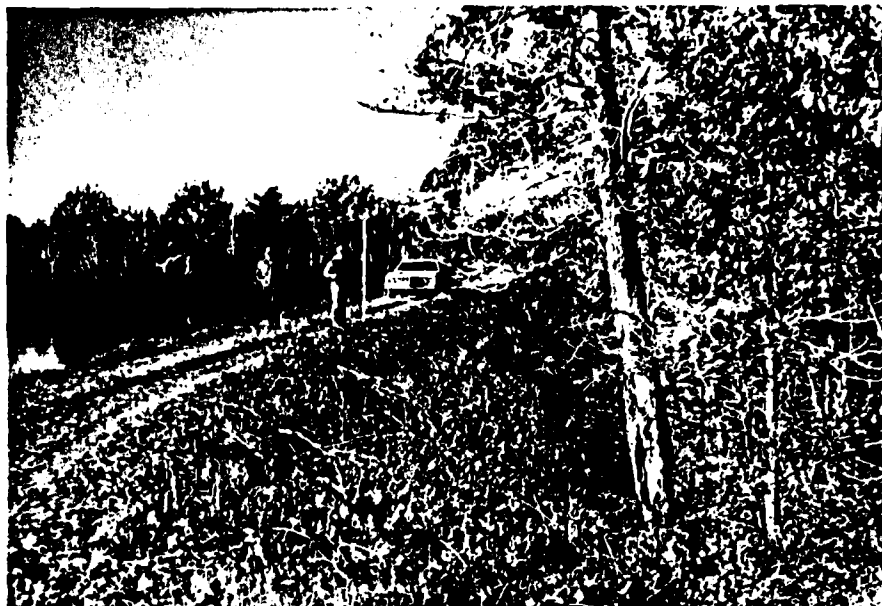
b. Embankment. Both embankments appear in fair condition. The downstream slopes of both embankments are covered with a stubble of brush. Remains of a fairly recent brush cut were deposited along the downstream toe of the embankments. On the day of the inspection, newly fallen leaves covered both the cut brush and the stubble, making observation of some areas difficult. On the upstream slopes of both embankments, the riprap extends only up to the normal pool elevation. The tops of both embankments have low areas, as described in the survey information in Appendix B. The lowest area is 0.5 foot below design elevation on the left embankment and 0.3 foot on the right embankment.

A. Right Embankment
Downstream Slope

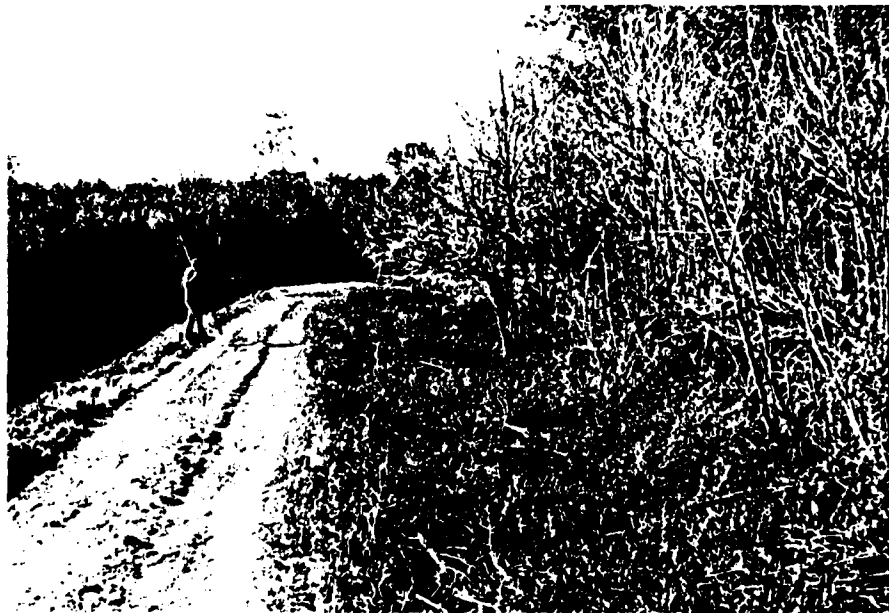
D. Left Embankment
View from Right Abutment

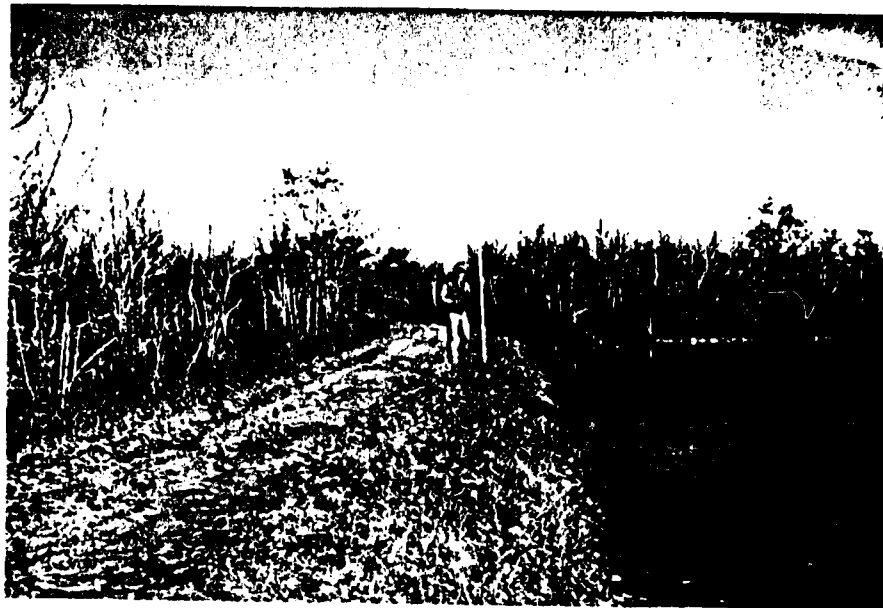
E. Left Embankment
View from Spillway at Left Abutment

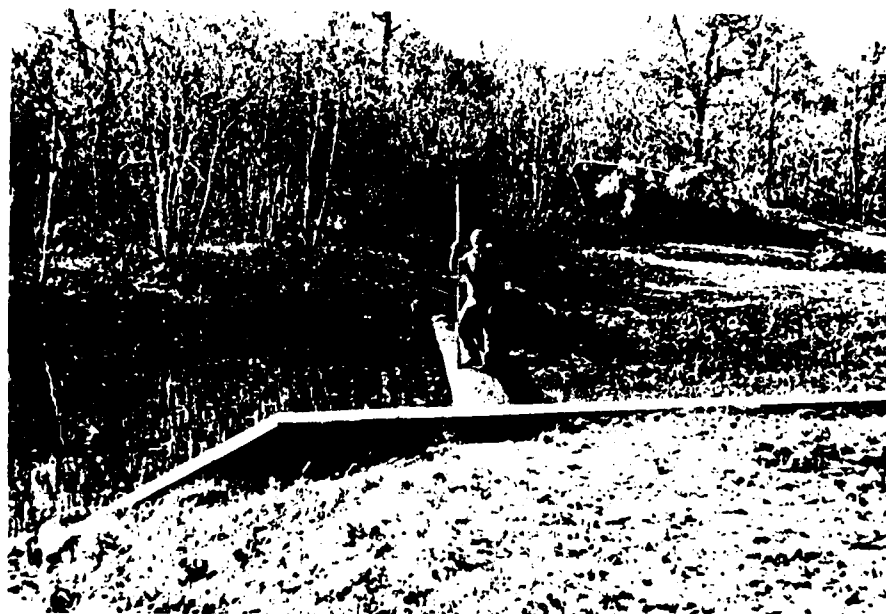
The spillway is in generally good condition. At the junction of the weir and the right wall, the concrete is slightly spalled. The spillway apron downstream of the weir is a short reach of exposed bedrock. Downstream of the apron, the channel is only 1 foot deep and 3 feet wide. Substantial spillway discharges would mostly travel overland.

(3) Appurtenant Structures. The spalling observed at the spillway is of little concern if it does not continue. The depression at the junction of the upstream embankment slope and the outlet works pipe could be cause for concern. The 1914 Pennsylvania Water Supply Commission Report states that the intake was a timber box structure, as shown in profile on Plate 5. No evidence of this structure was observed. The depression may have been the foundation of the structure. It also could be an indication of more serious problems.

F. Spillway at Left Abutment
of Left Embankment
